SWDA Bigelow Court Final Status Survey Report
Sidewall Sample Location Photographs

Excavation Inspection Report

TO: John R. Hackett, PE, CHP, PMP
FROM: Owen C. Chao, PE
SUBJECT: Excavation Inspection at Treasure Island Naval Station RADMAC CTO-10
Bigelow Court Solid Waste Disposal Area
DATE: 9/14/2014
CC: Project File

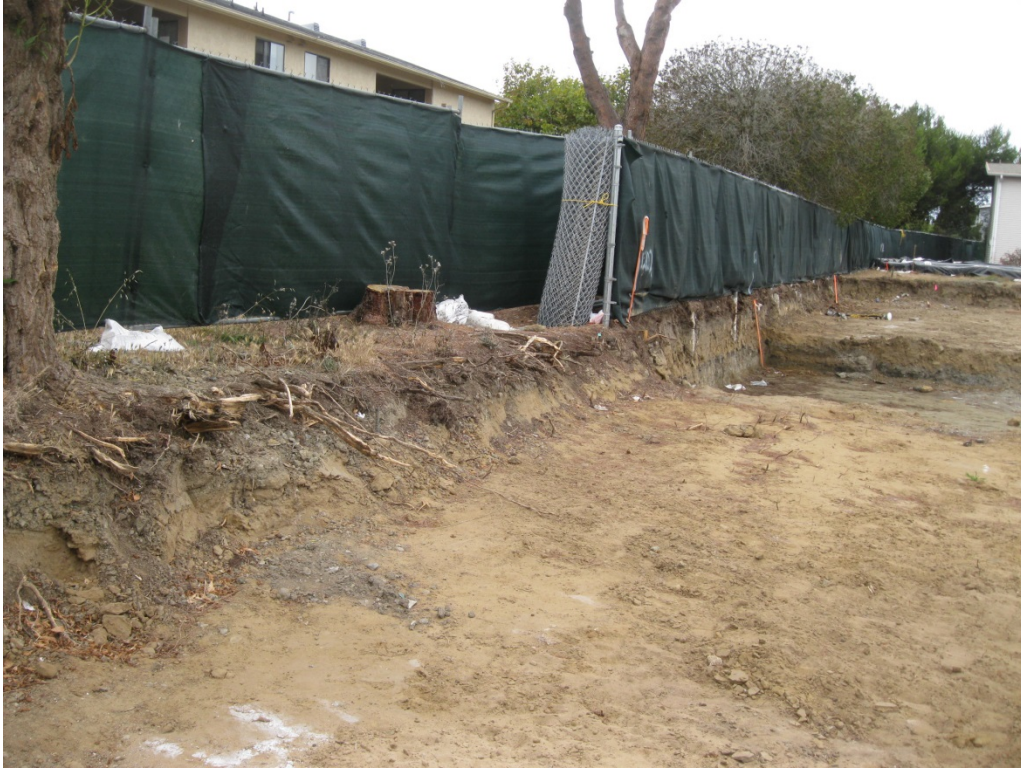
Photograph 1 – Excavation Ex A Sidewall, Facing West – August 14, 2014

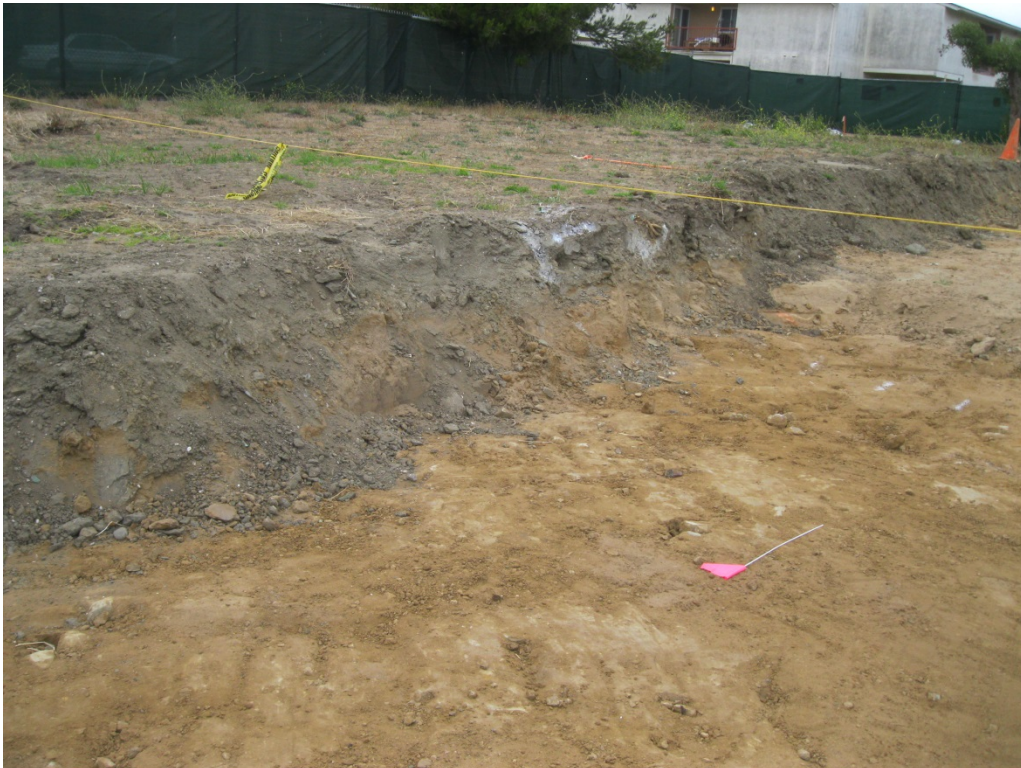
Photograph 2 – Excavation Ex A Sidewall, Facing South – August 14, 2014

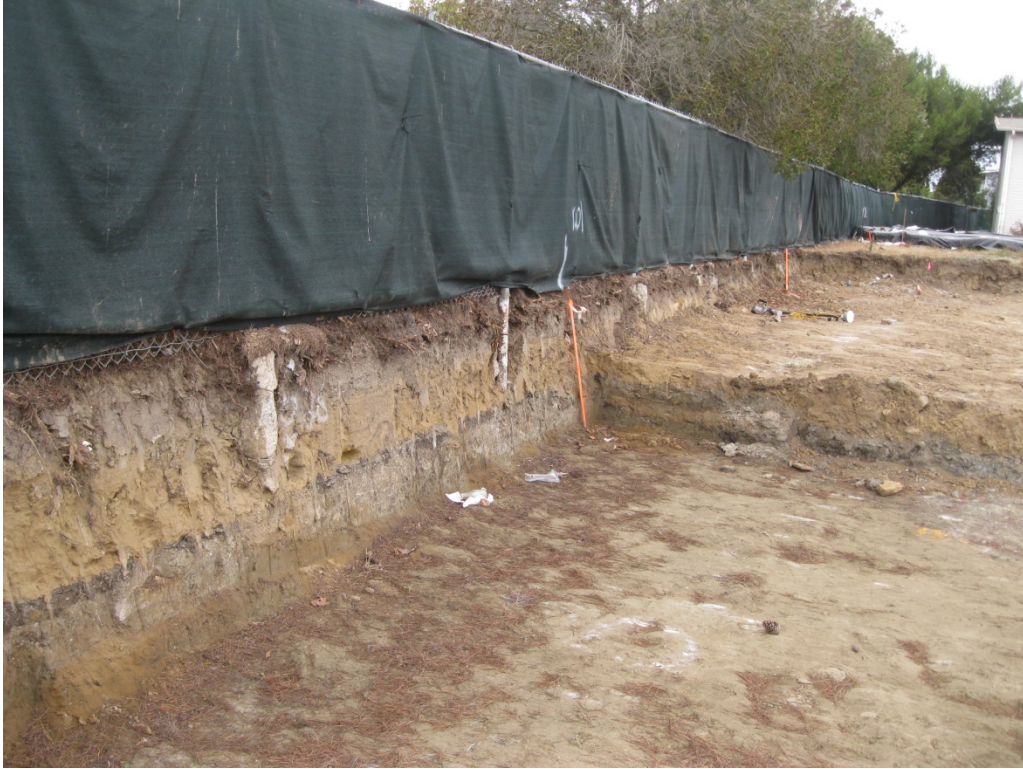
Photograph 3 - Excavation Ex B Sidewall, Facing West – August 14, 2014

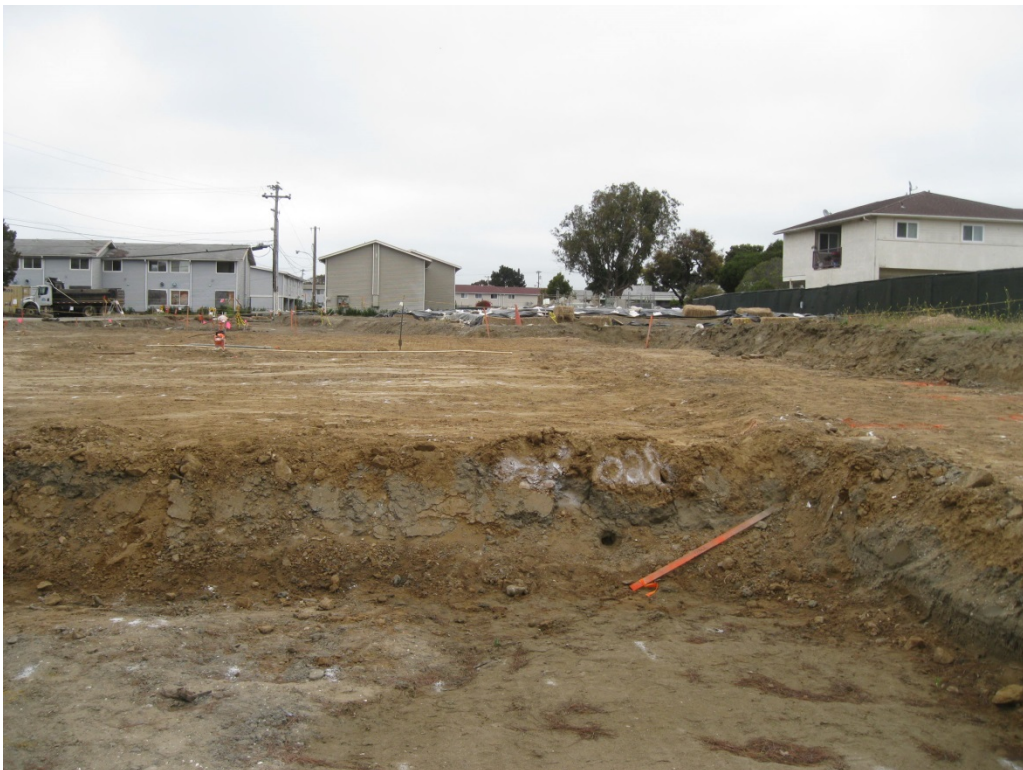
Photograph 4 – Excavation Ex B Sidewall, Facing Northeast – August 14, 2014

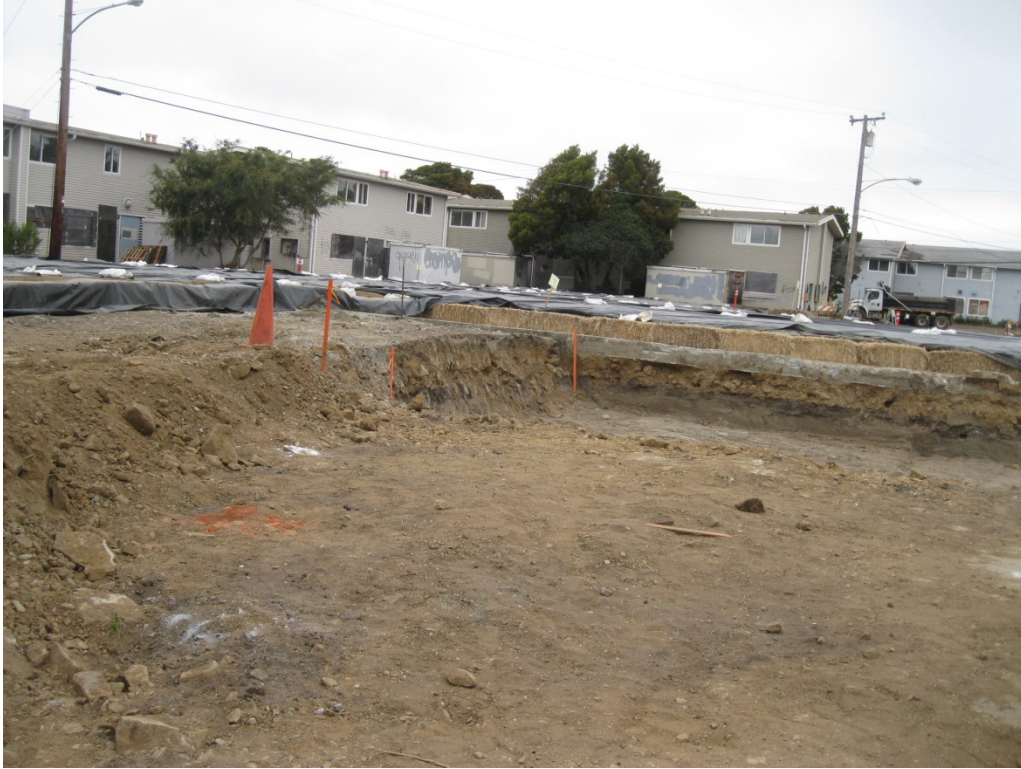
Photograph 5 - Excavation Ex C, Facing North – August 14, 2014

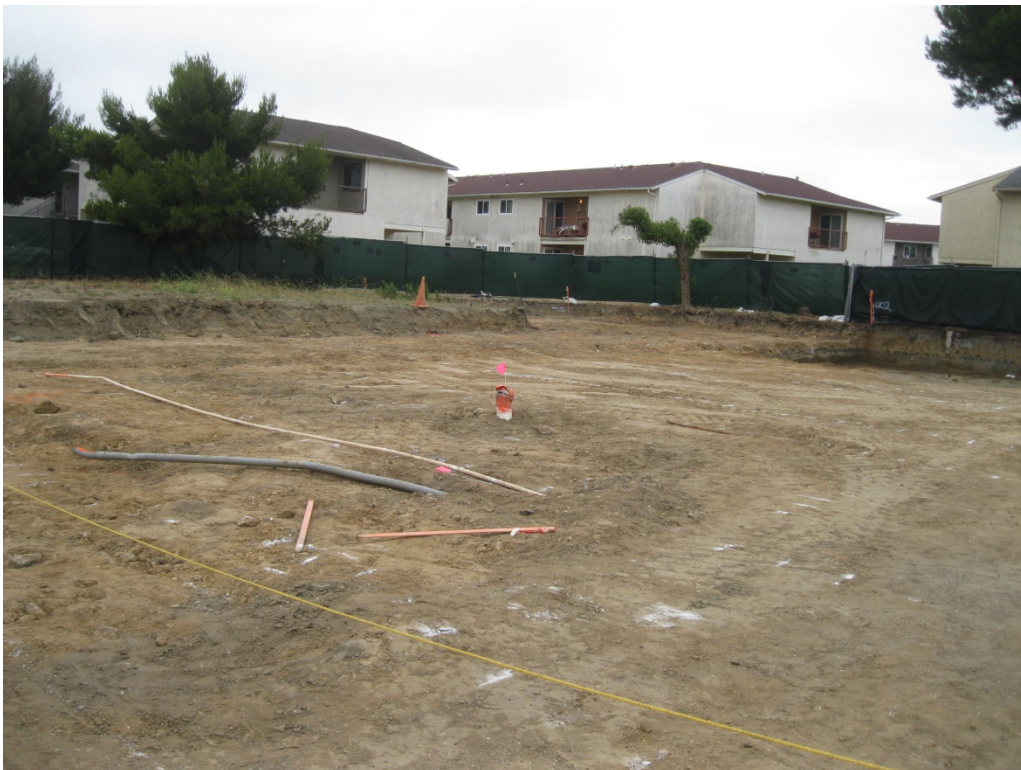
Photograph 6 – Excavation Ex C, Facing South – August 14, 2014

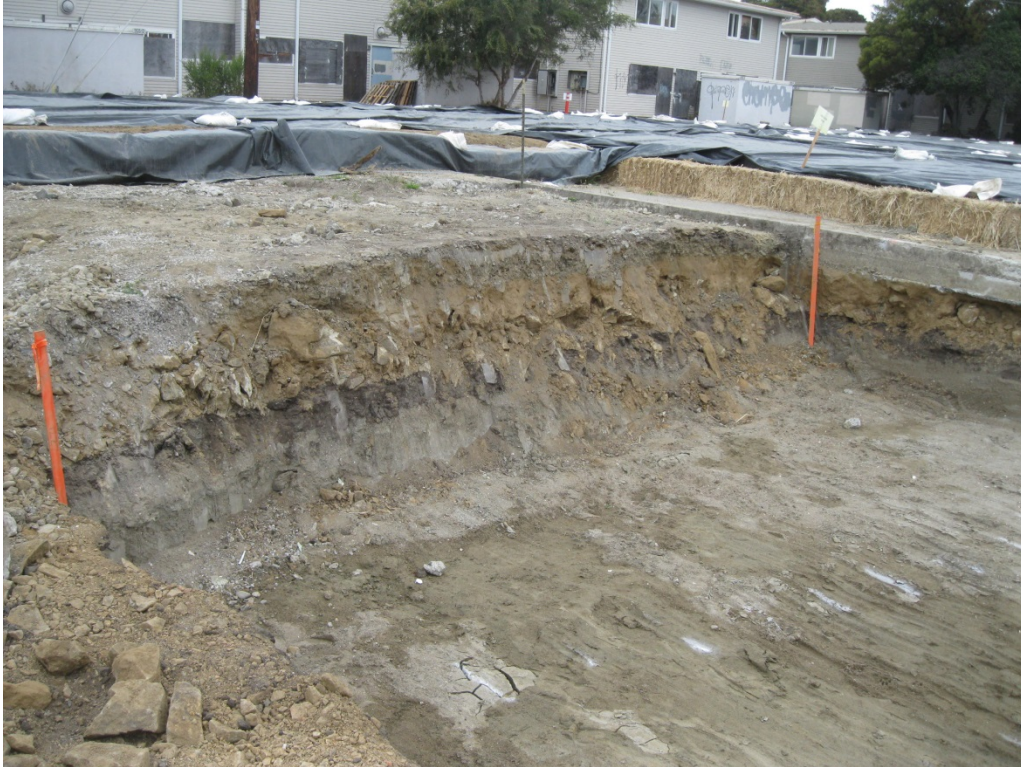
Photograph 7 - Excavation Ex D Sidewall, Facing North – August 14, 2014

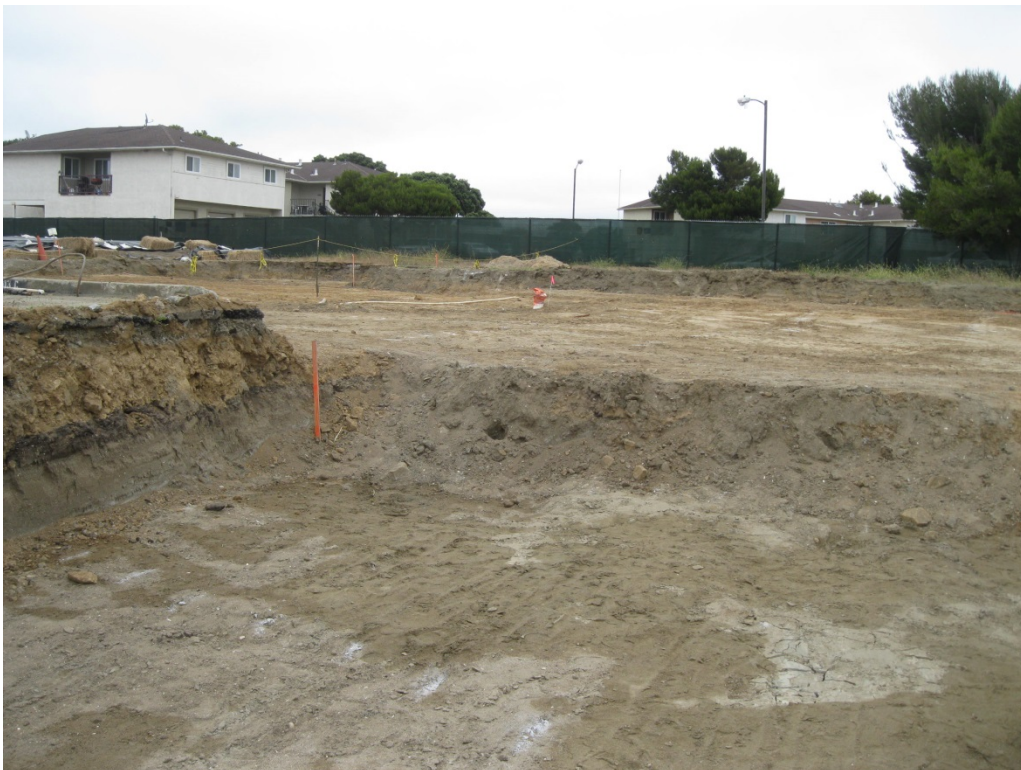
Photograph 8 – Excavation Ex D, Facing East – August 14, 2014

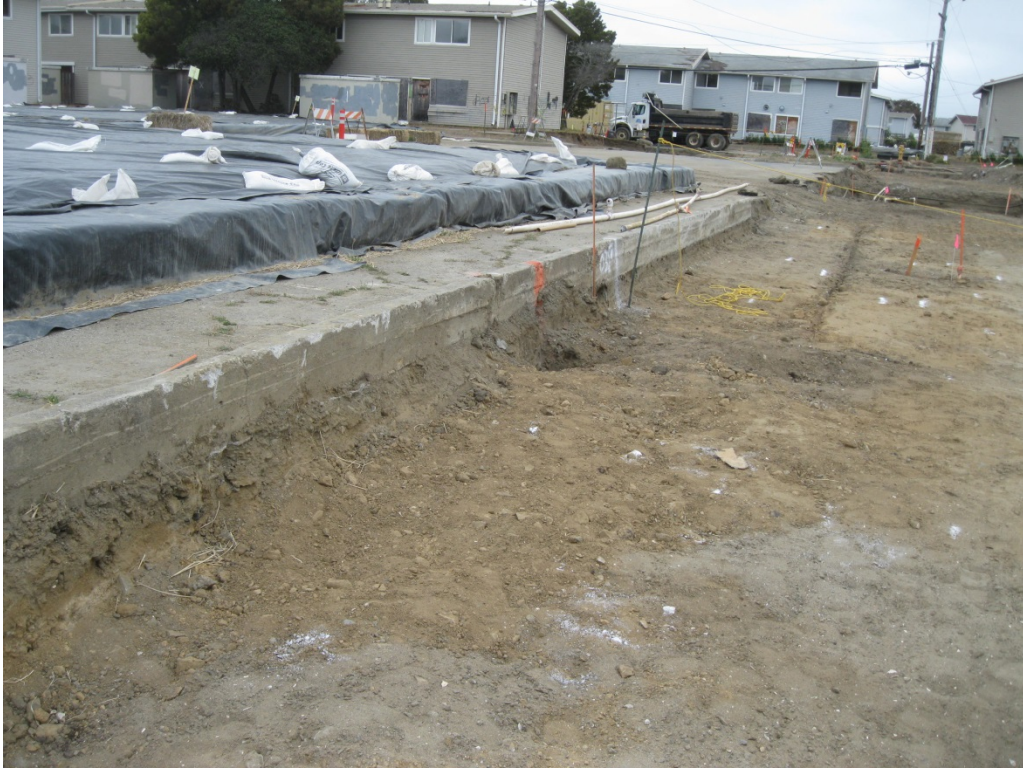
Photograph 9 - Excavation Ex E Sidewall, Facing North – August 14, 2014

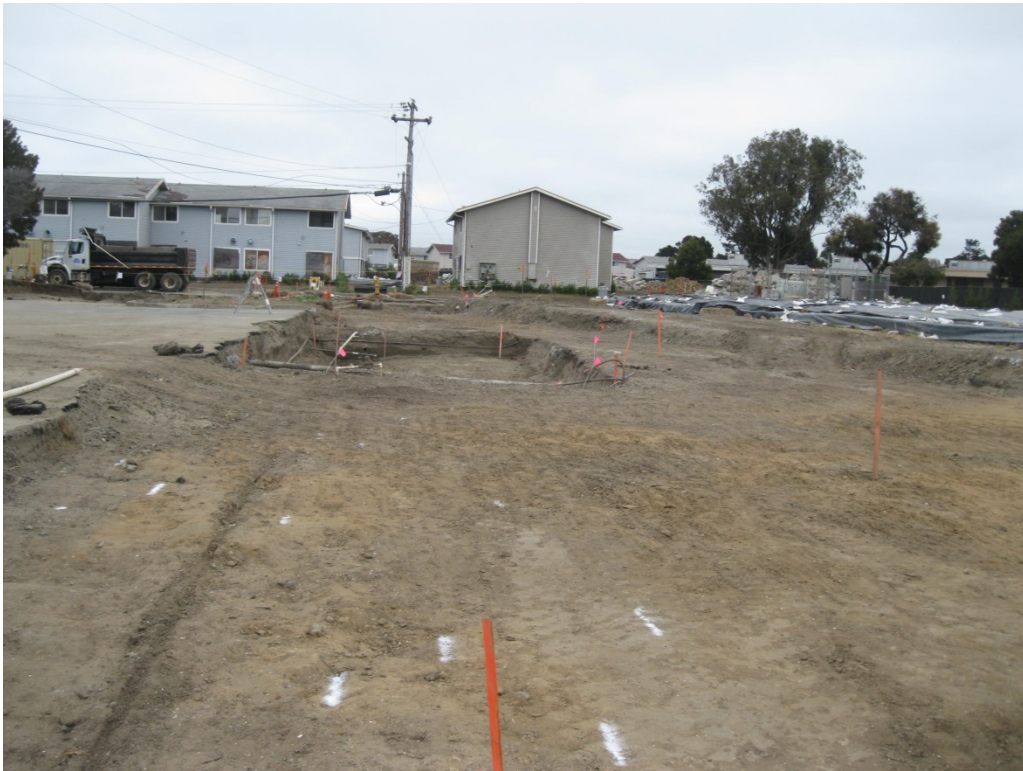
Photograph 10 – Excavation Ex E, Facing Northeast – August 14, 2014

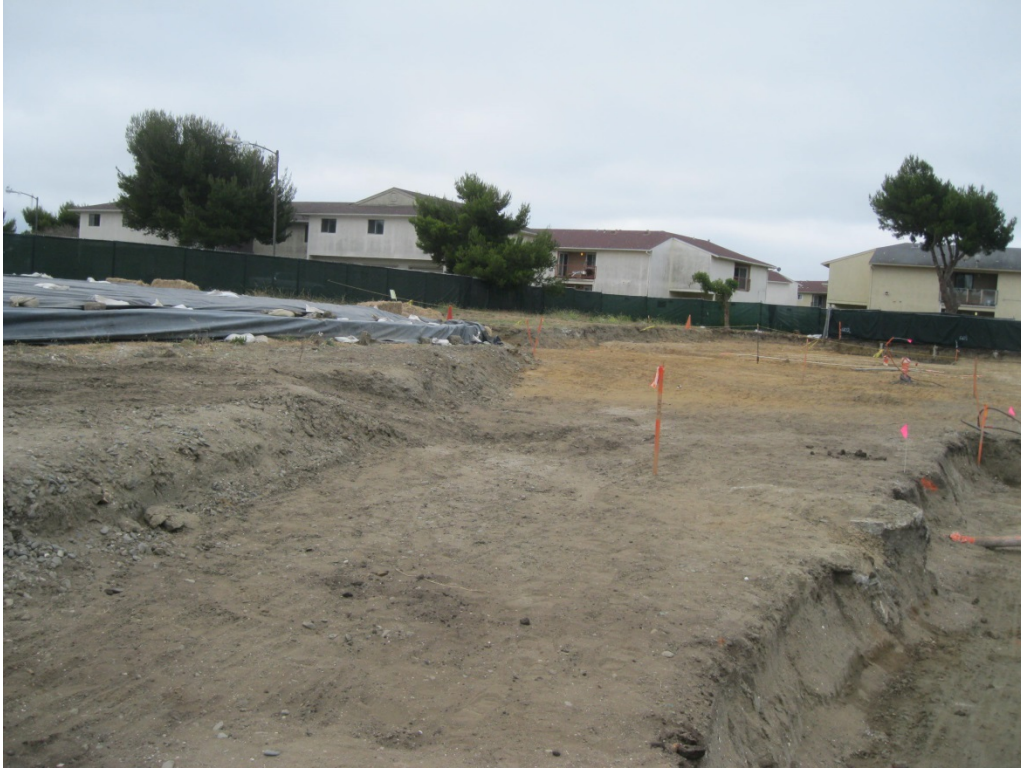
Photograph 11 - Excavation Ex F, Facing South – August 14, 2014

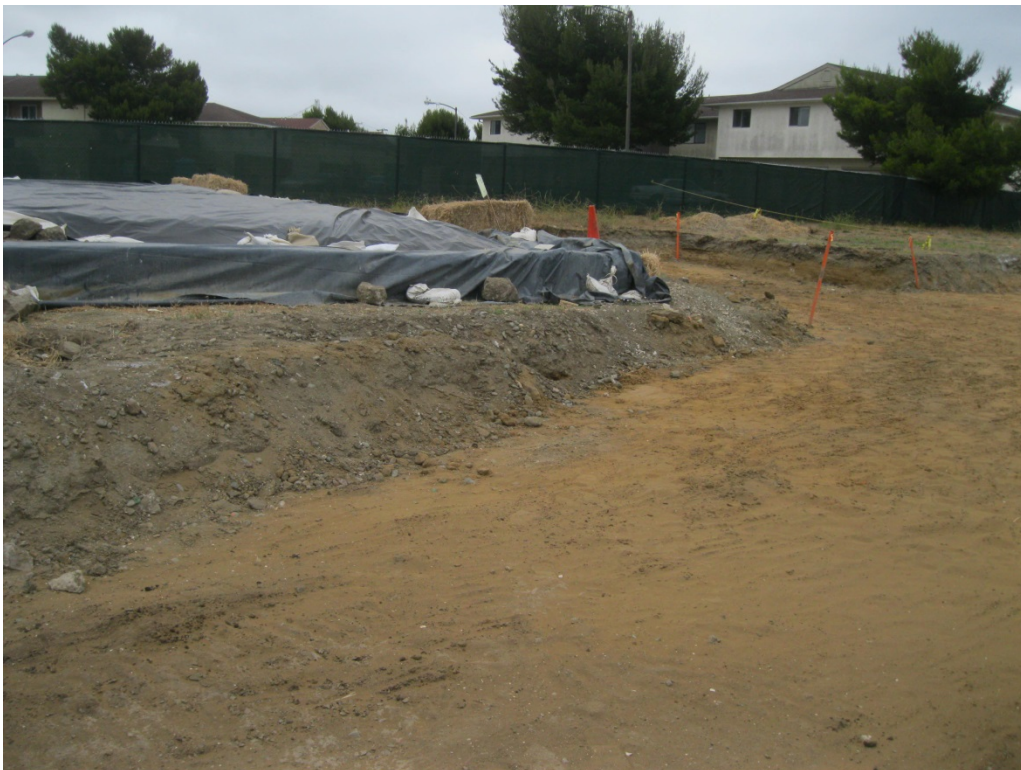
Photograph 12 – Excavation Ex F Sidewall, Facing Southeast – August 14, 2014

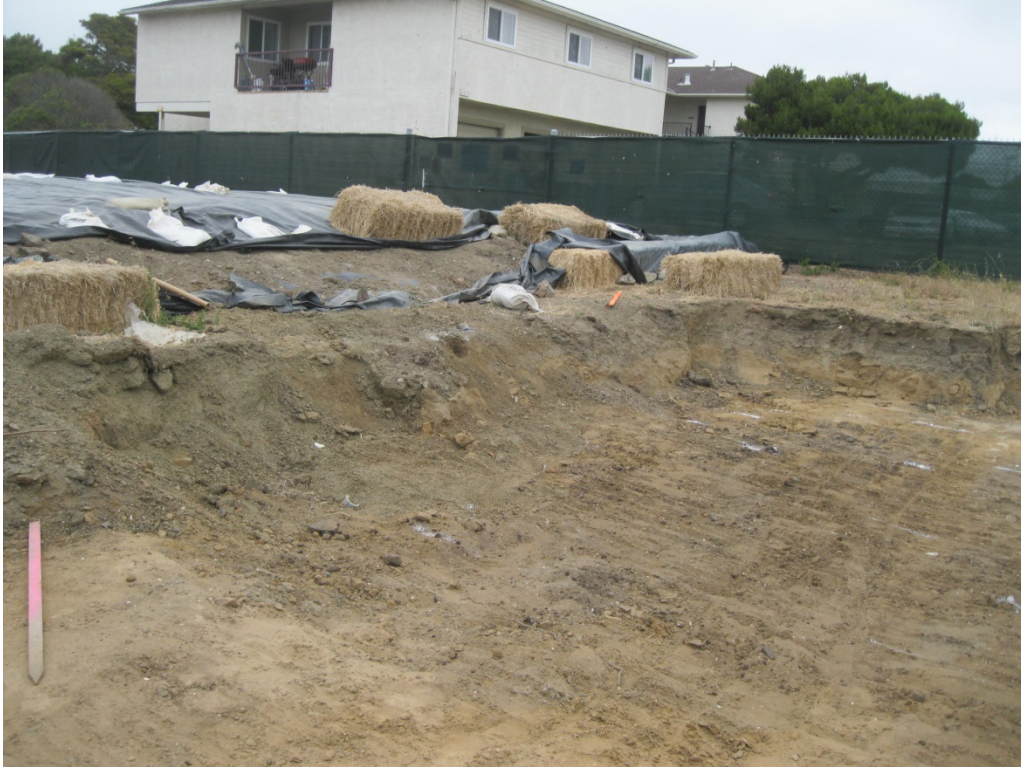
Photograph 17 - Excavation Ex G Sidewall, Facing East – August 14, 2014

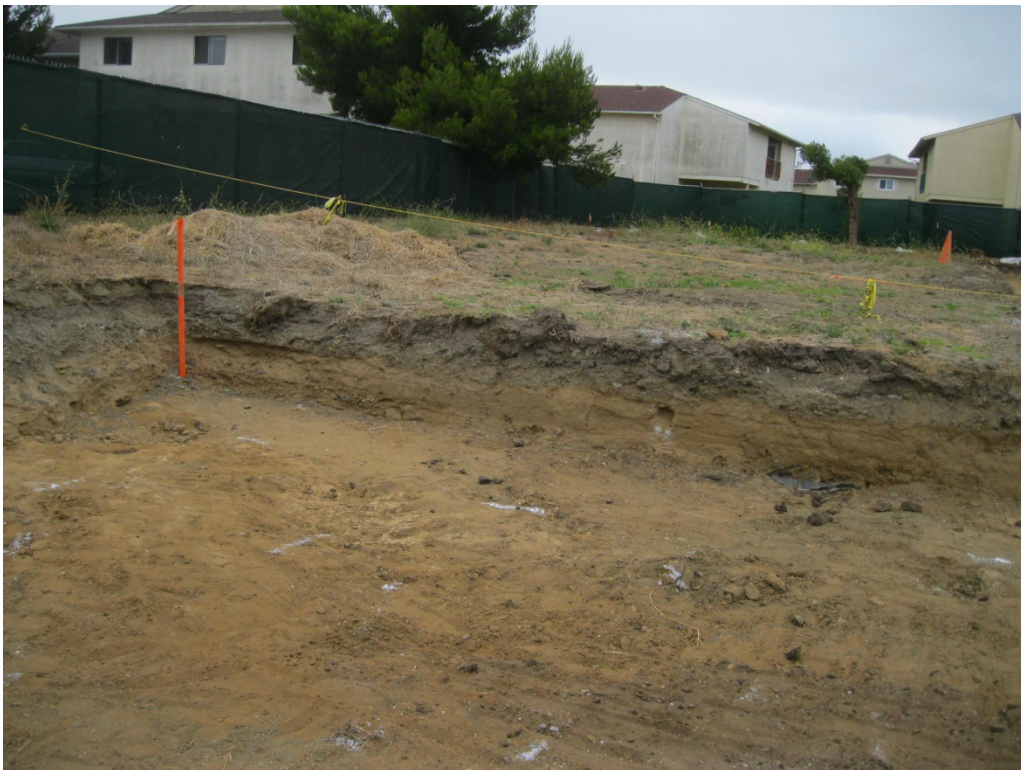
Photograph 18 – Excavation Ex G Sidewall, Facing South – August 14, 2014

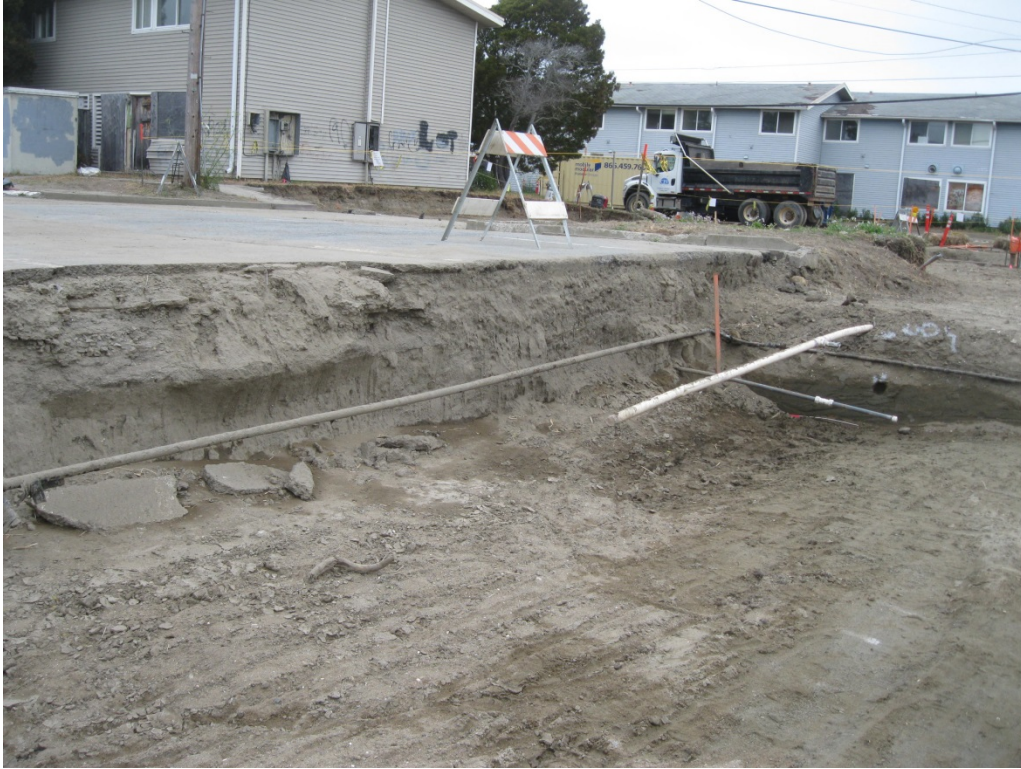
Photograph 15 - Excavation Ex H, Facing North – August 14, 2014

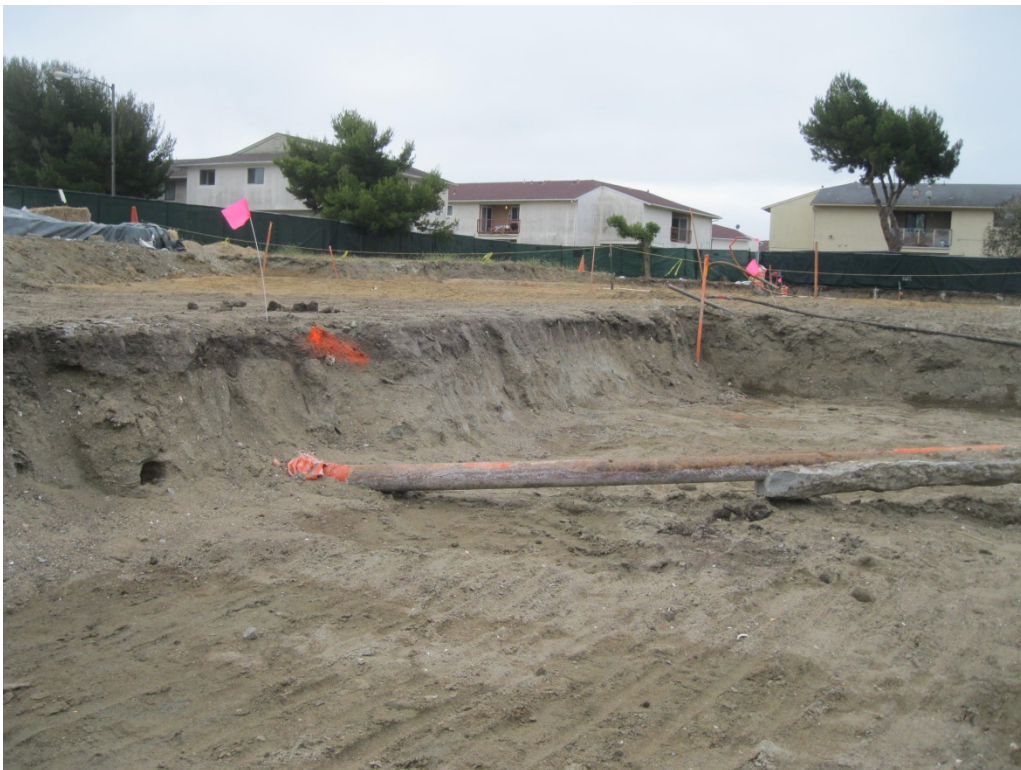
Photograph 16 – Excavation Ex H Sidewall, Facing South – August 14, 2014

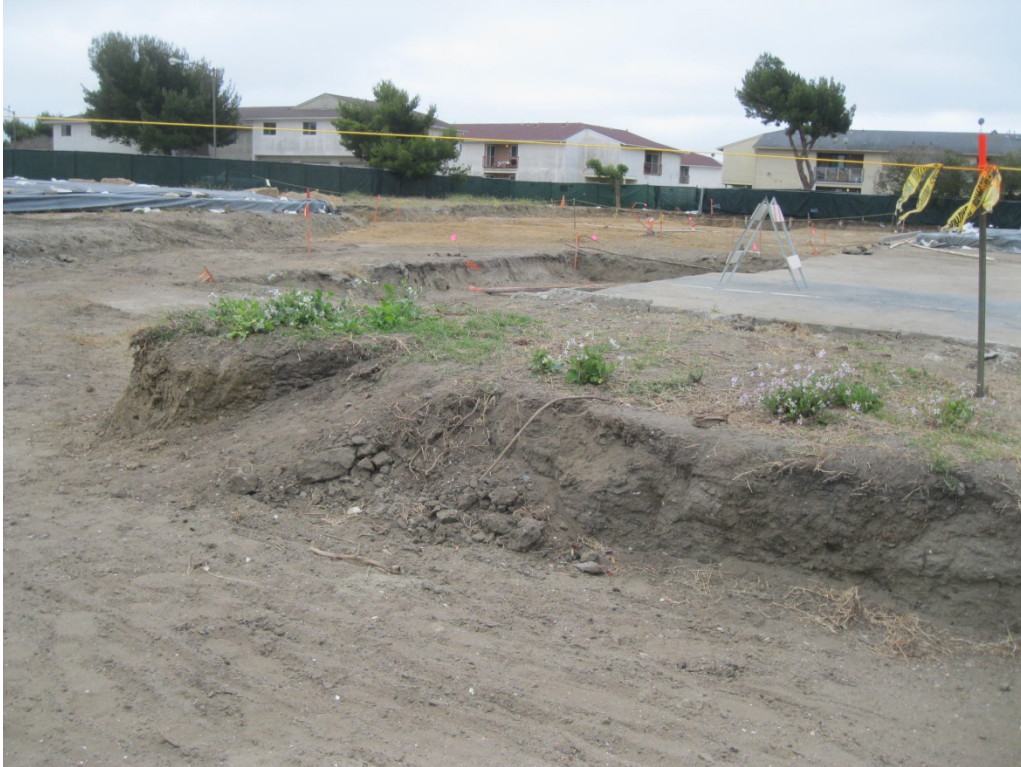
Photograph 17 - Excavation Ex I Sidewalk, Facing South – August 14, 2014

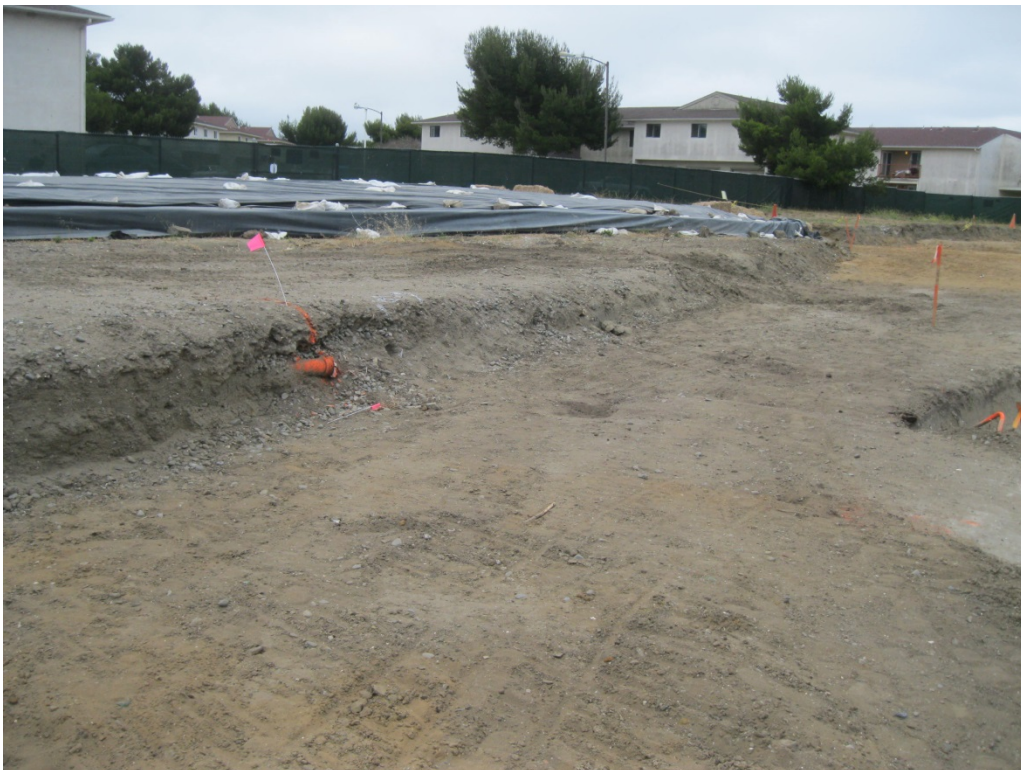
Photograph 18 – Excavation Ex I, Facing South – August 14, 2014

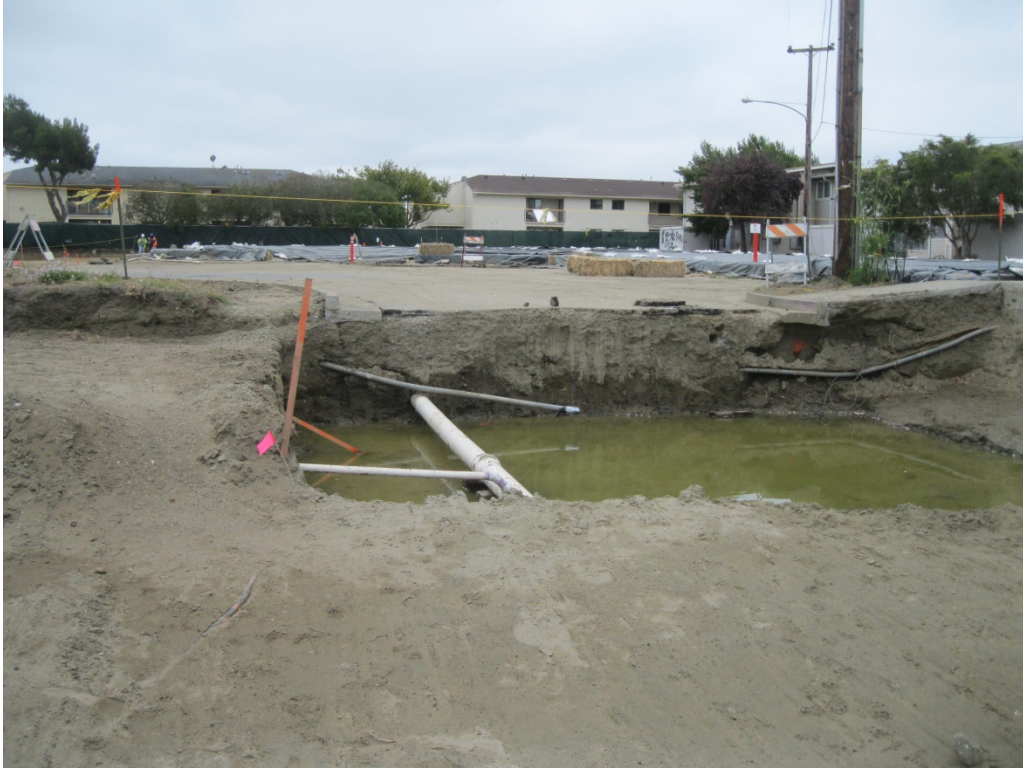
Photograph 19 - Excavation Ex J, Facing Southwest – August 14, 2014

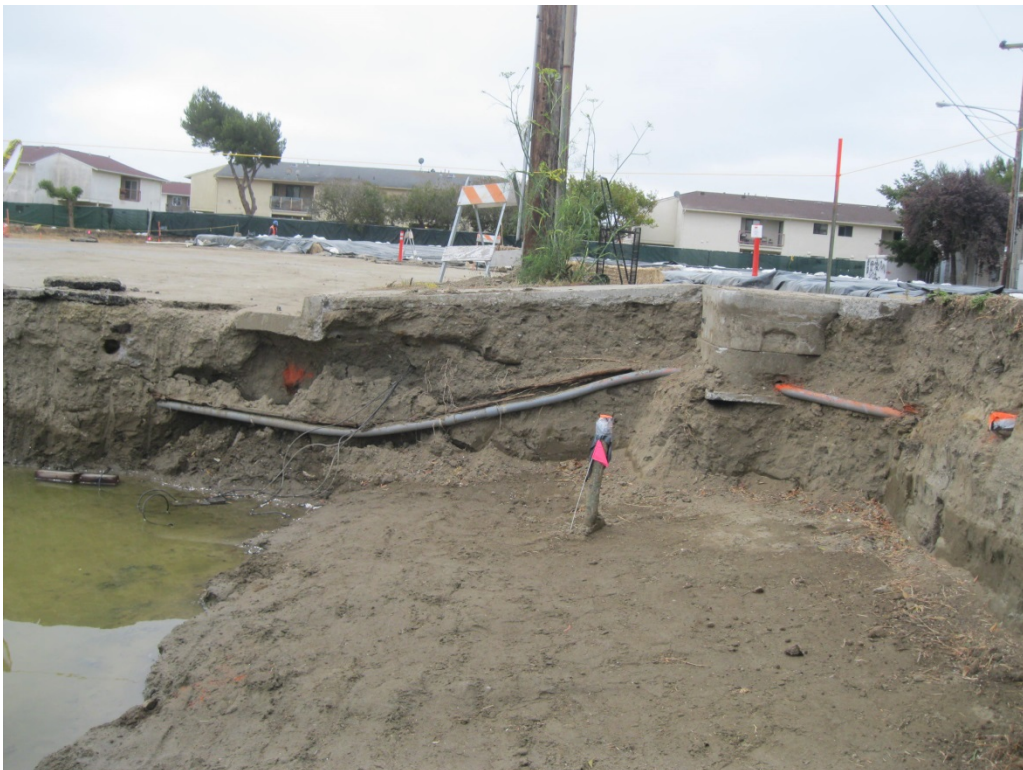
Photograph 20 – Excavation Ex J, Facing Southwest – August 14, 2014

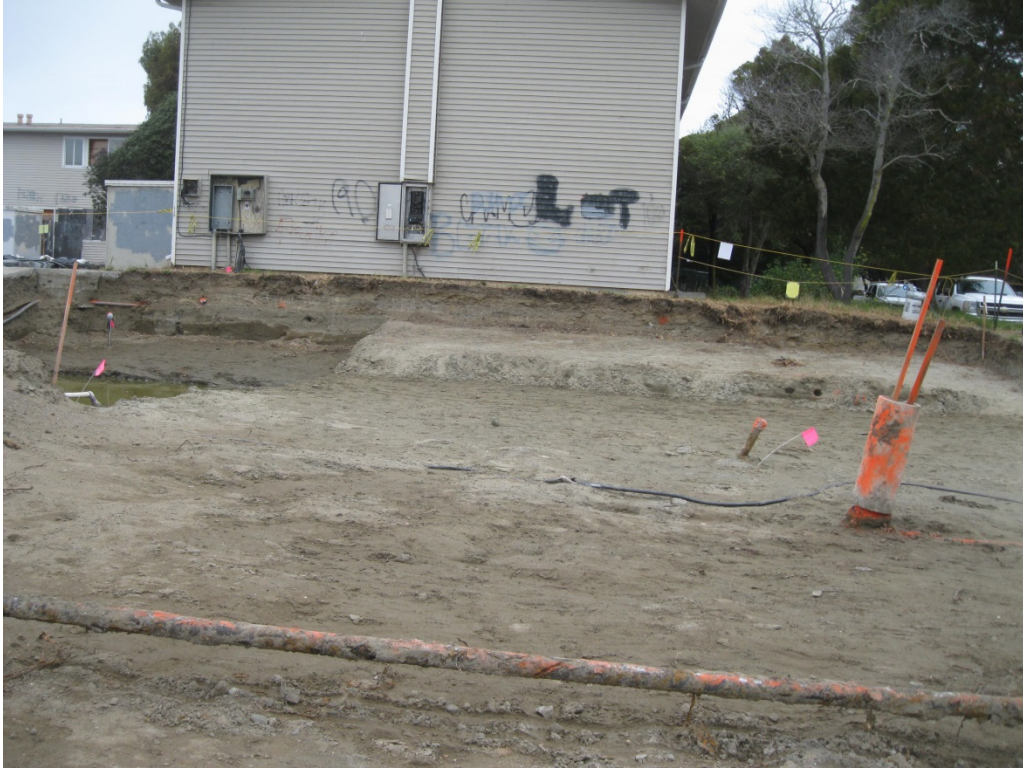
Photograph 21 - Excavation Ex K, Facing East – August 14, 2014

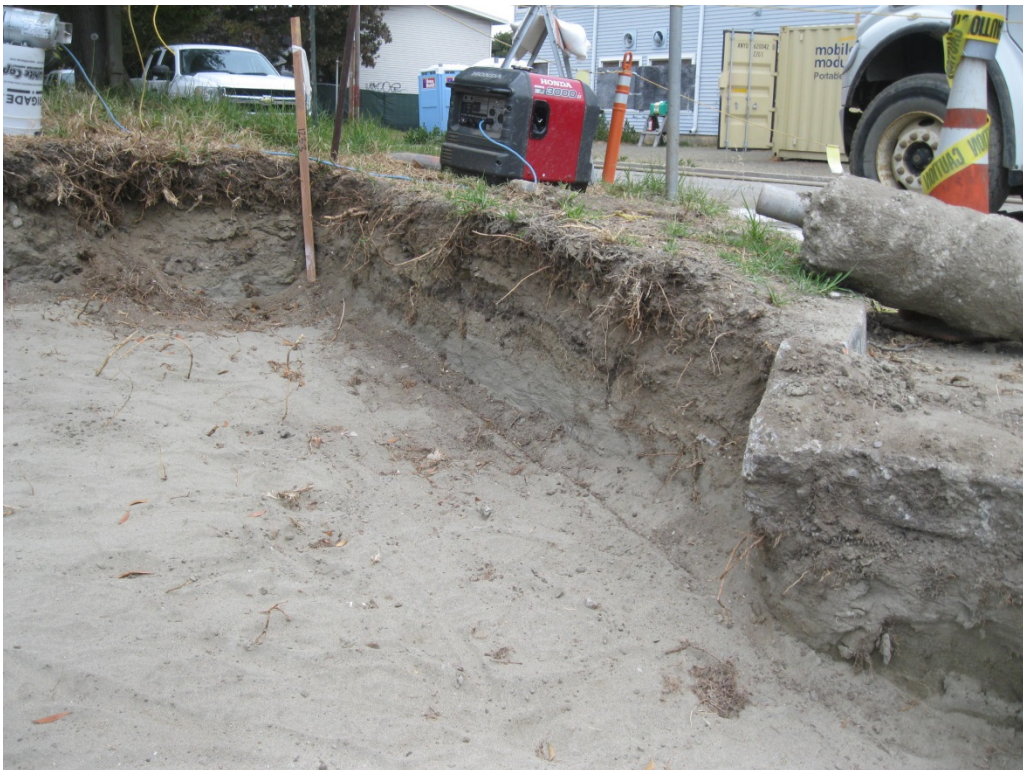
Photograph 22 – Excavation Ex K, Facing Northwest – August 14, 2014

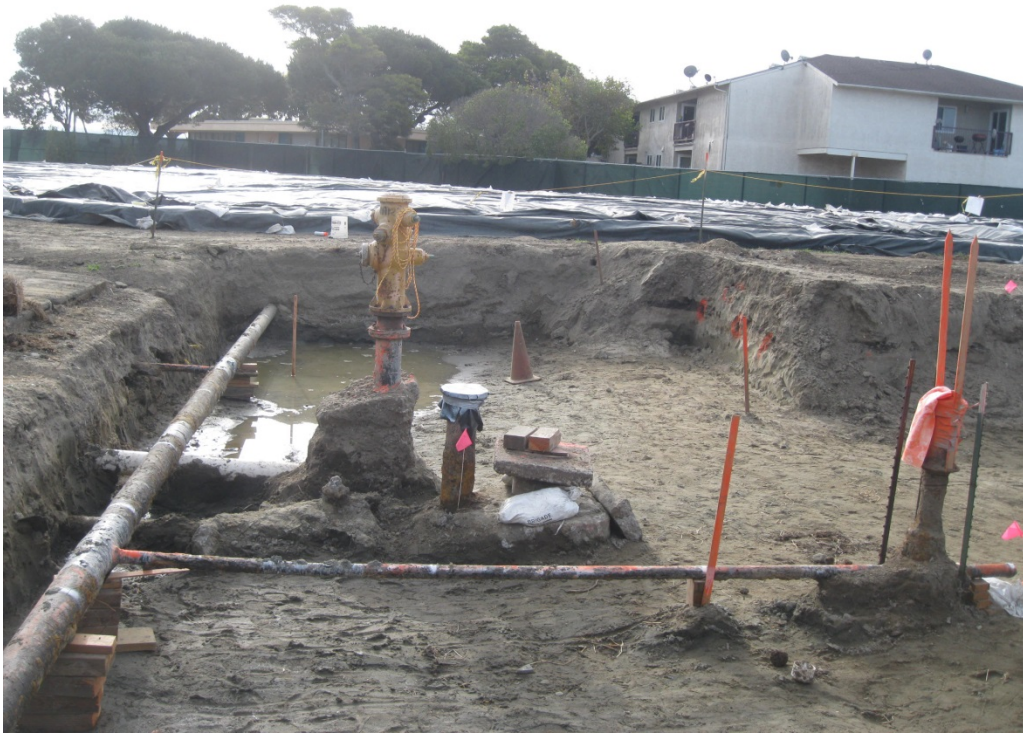
Excavation bottom and sidewall of Excavation Ex L were re-inspected on August 26, 2014 and there was no evidence of solid waste or other sign of contamination. Final topographic survey data for all excavation areas were checked against pre-excavation topographic survey data, and all areas were excavated to the required depths in accordance with the Work Plan.

Photograph 23 - Excavation Ex L, Facing East – August 26, 2014

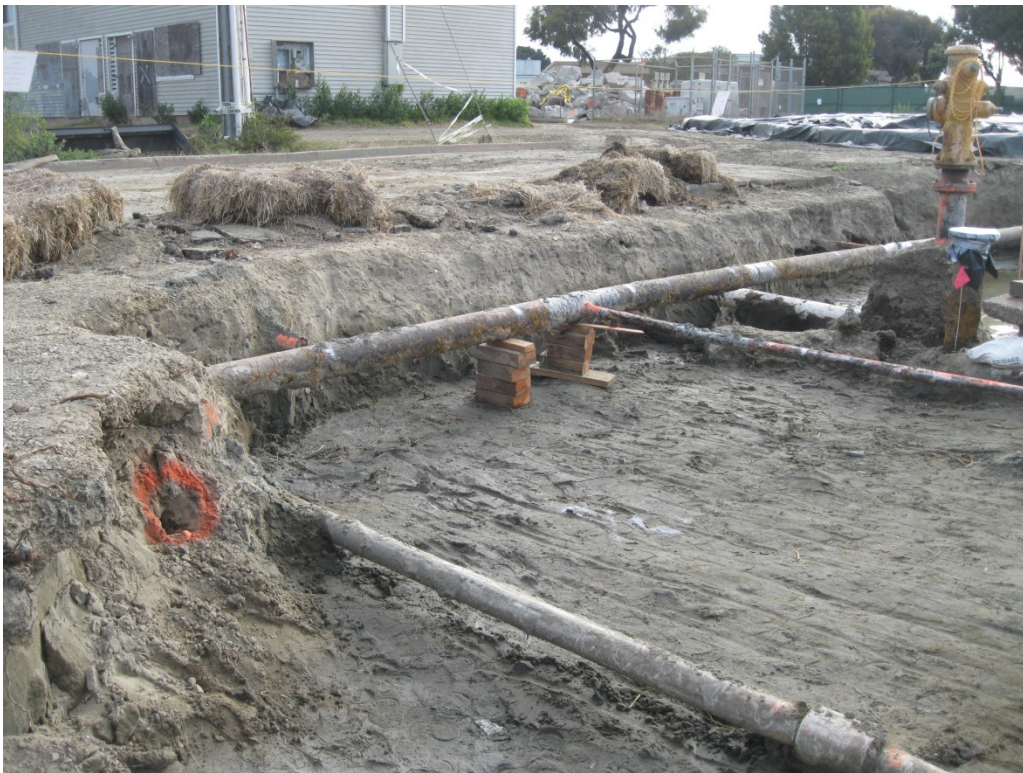
Photograph 24 – Excavation Ex L Sidewall, Facing Northeast – August 26, 2014

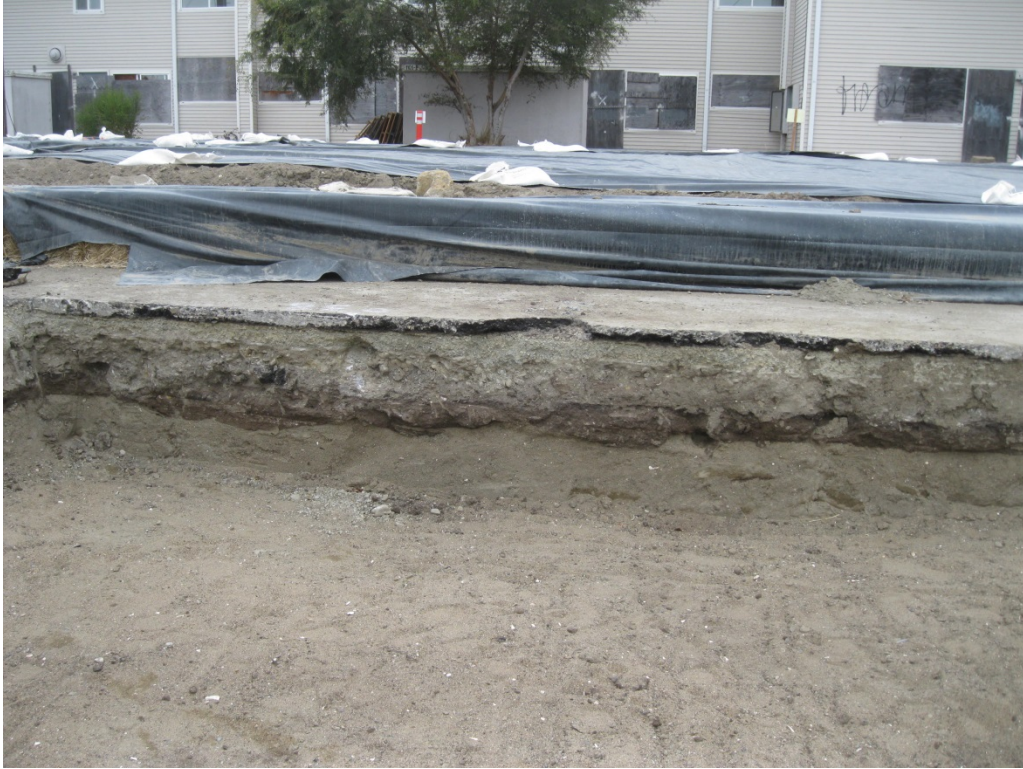
Photograph 25 - Excavation Ex M Sidewall, Facing West – August 14, 2014

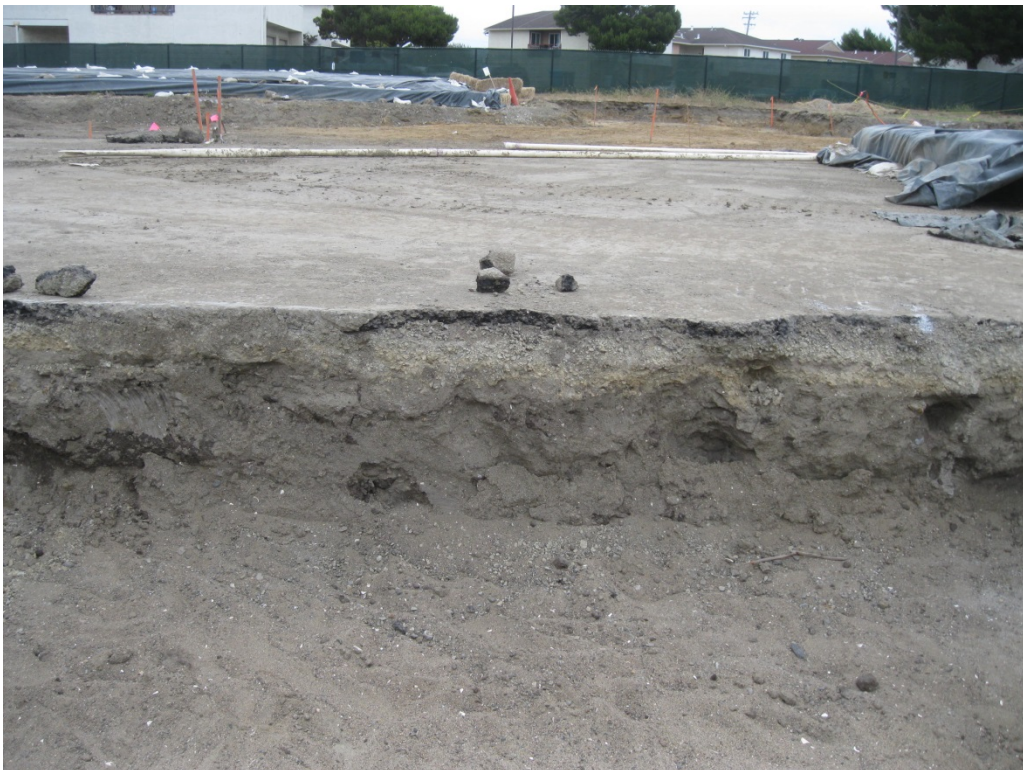
Photograph 26 – Excavation Ex M Sidewall, Facing East – August 14, 2014

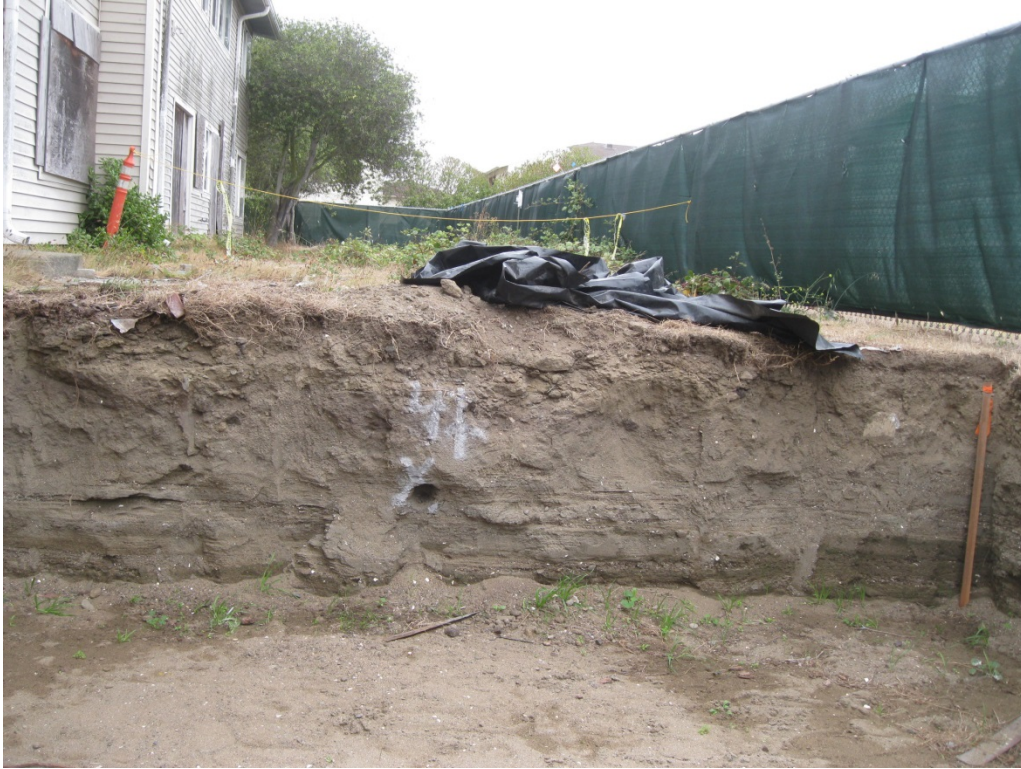
Photograph 27 - Excavation Ex N Sidewall, Facing South – August 14, 2014

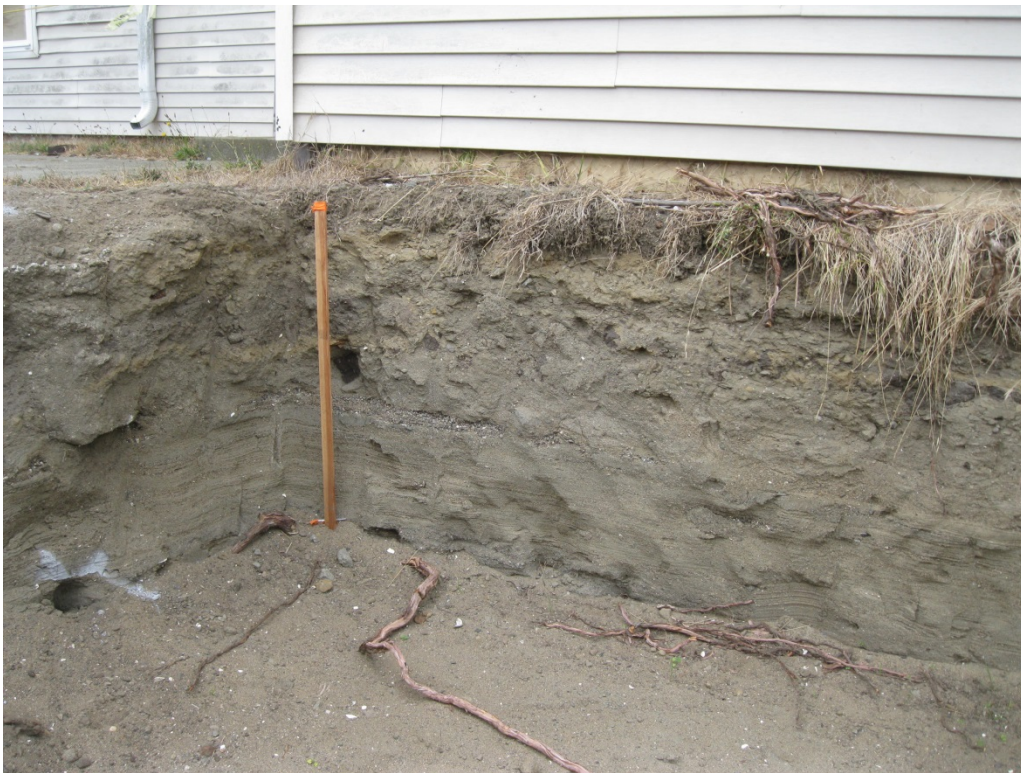
Photograph 28 – Excavation Ex N Sidewall, Facing East – August 14, 2014
